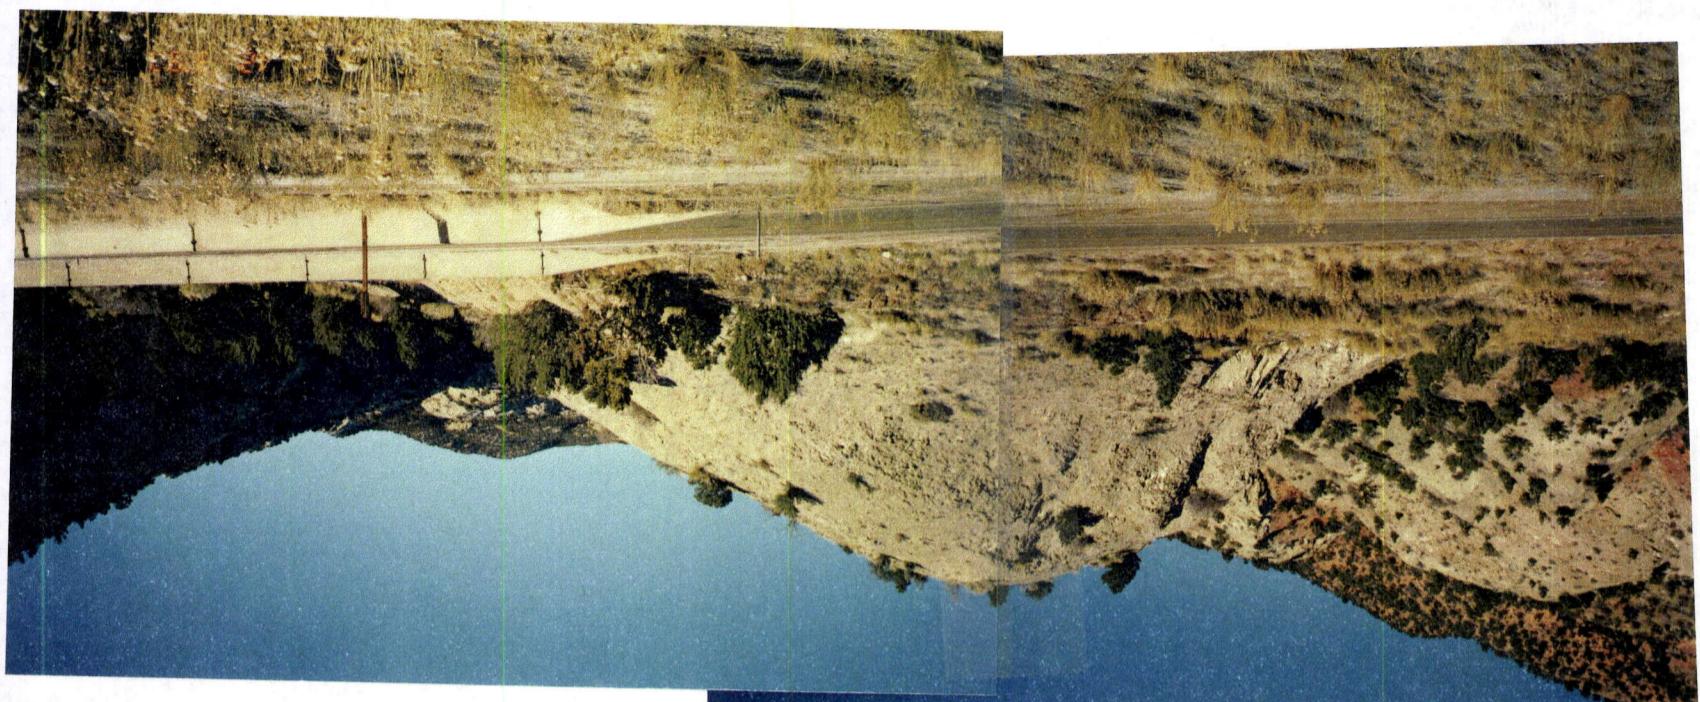
Photo of existing disturbance  
(bench + highwall(s))

West side of outcrop/ridge

gypsum

(View looking NNE)

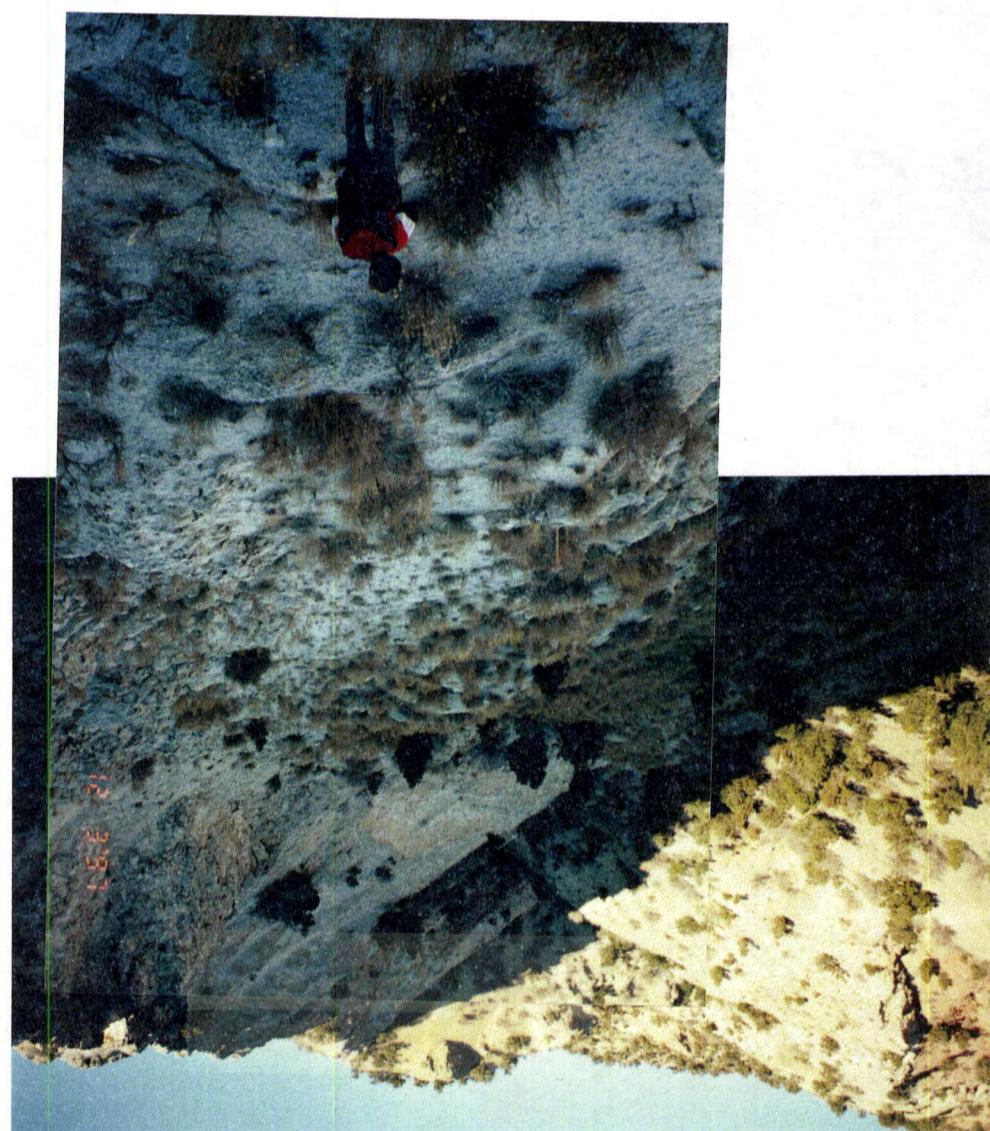
Photo looking North across  
previous disturbed bench  
area adjacent to highwall.

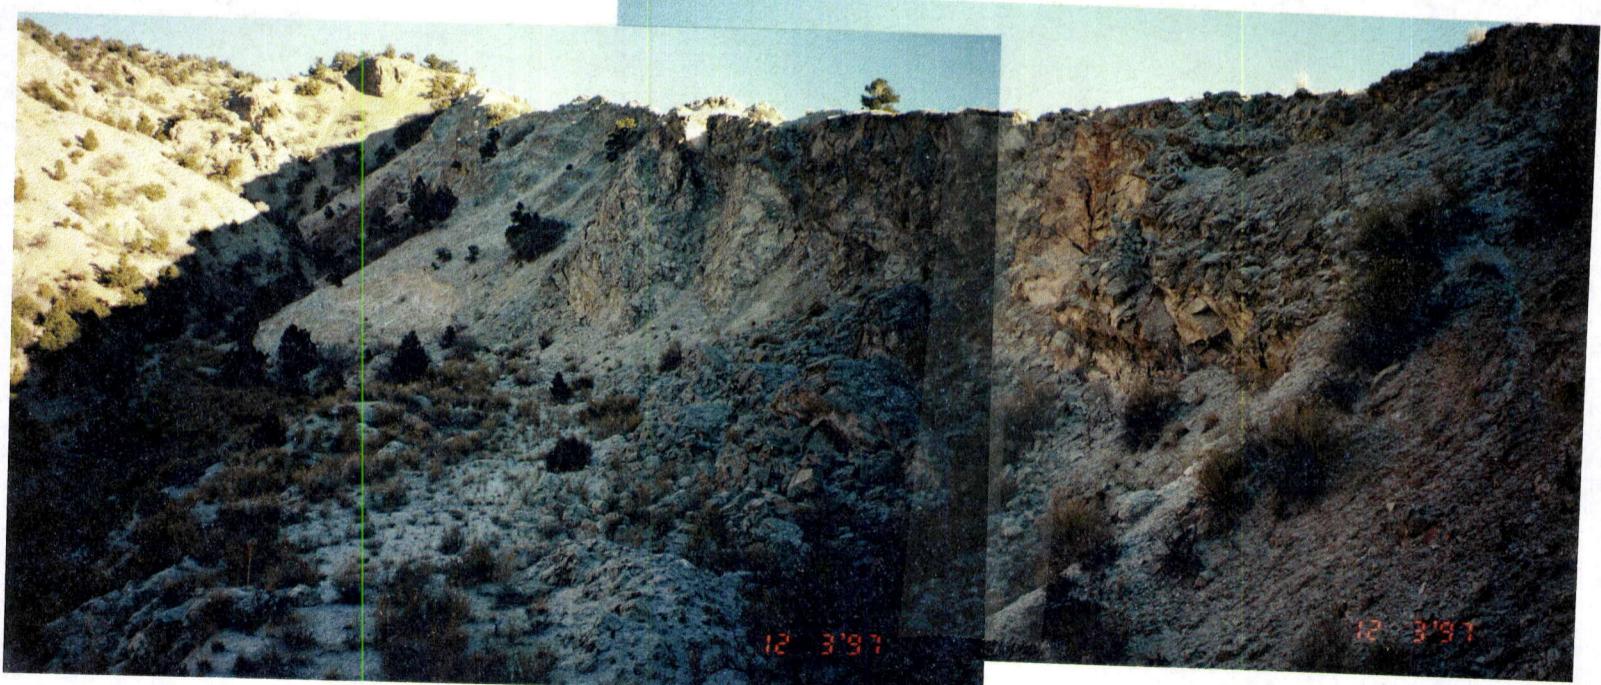
Photo of gypsum outcrop taken  
from across main highway leading  
up Cedar Cyn. from Cedar City.

Looking North onto project area.

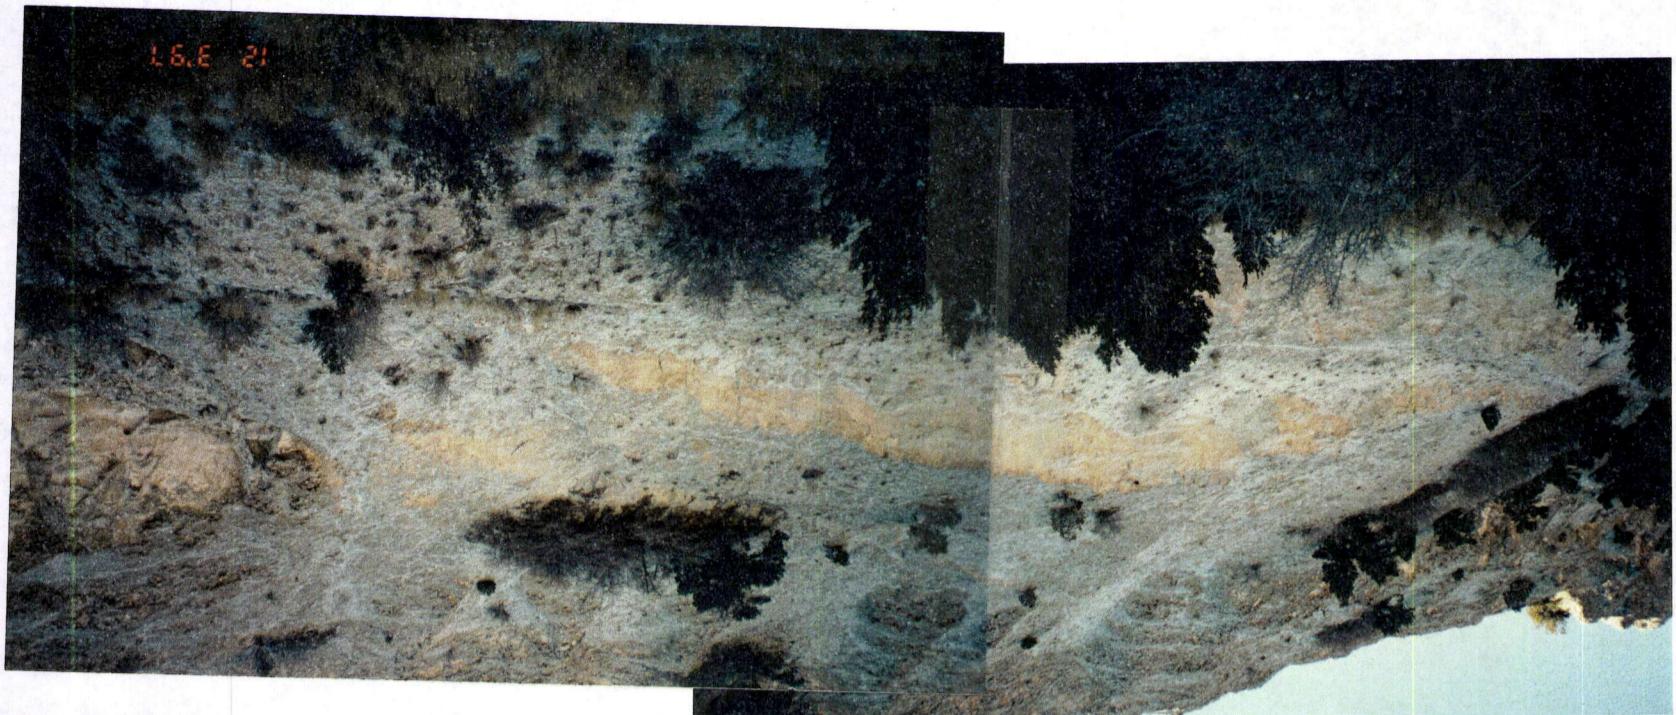
Photo looking SSW from old  
bench of previous mined  
disturbance.

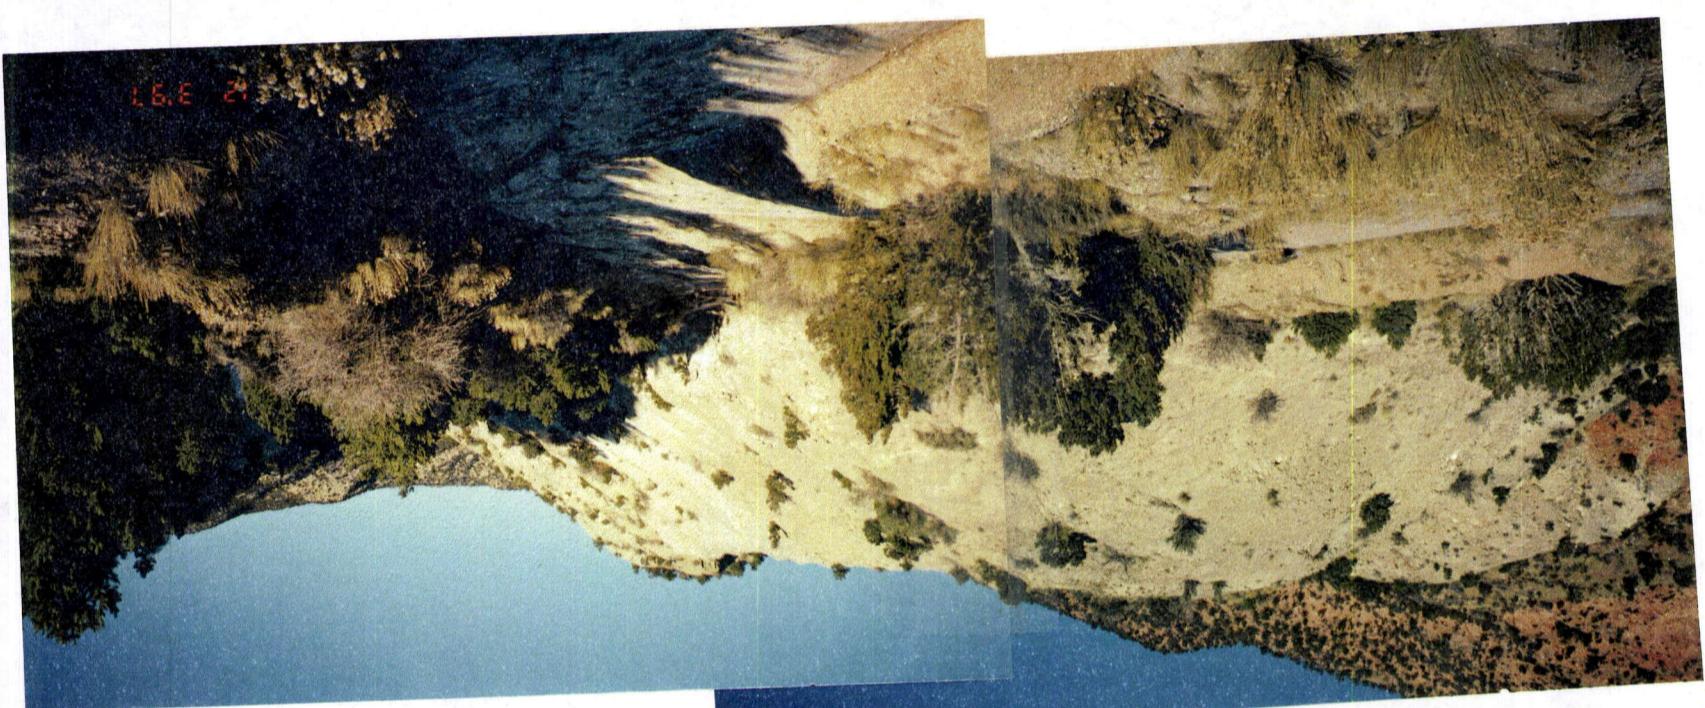
Photo looking East at the  
old (prelaw?) gypsum mine  
disturbance.

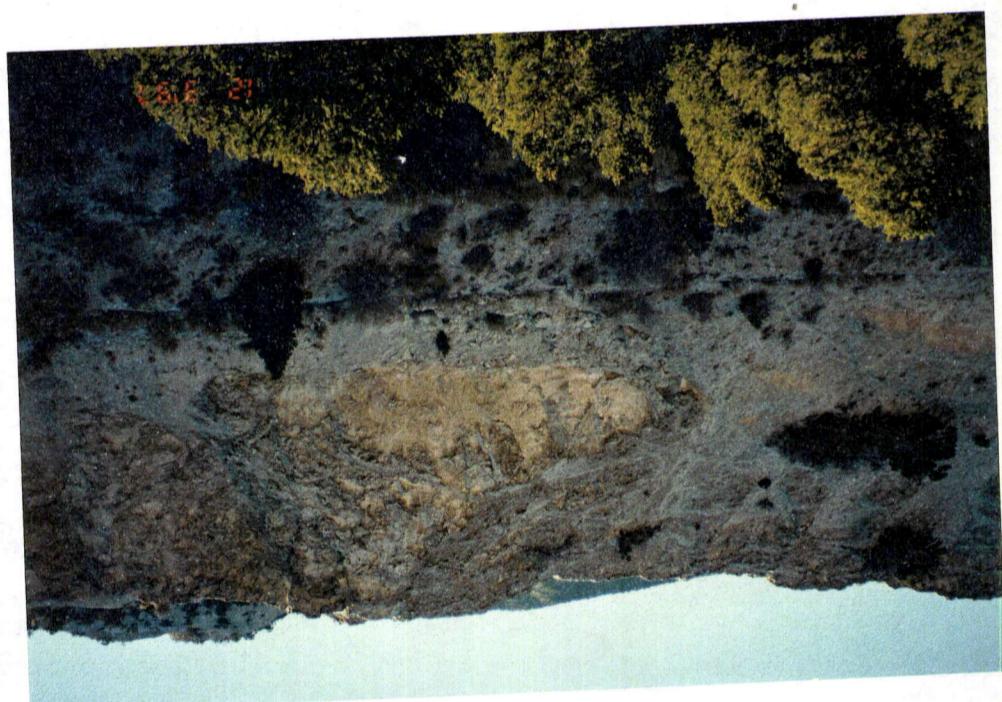
Photo taken from SE side of proposed  
project area looking NNE.

\* Dry Creek Drainage is in the  
foreground.

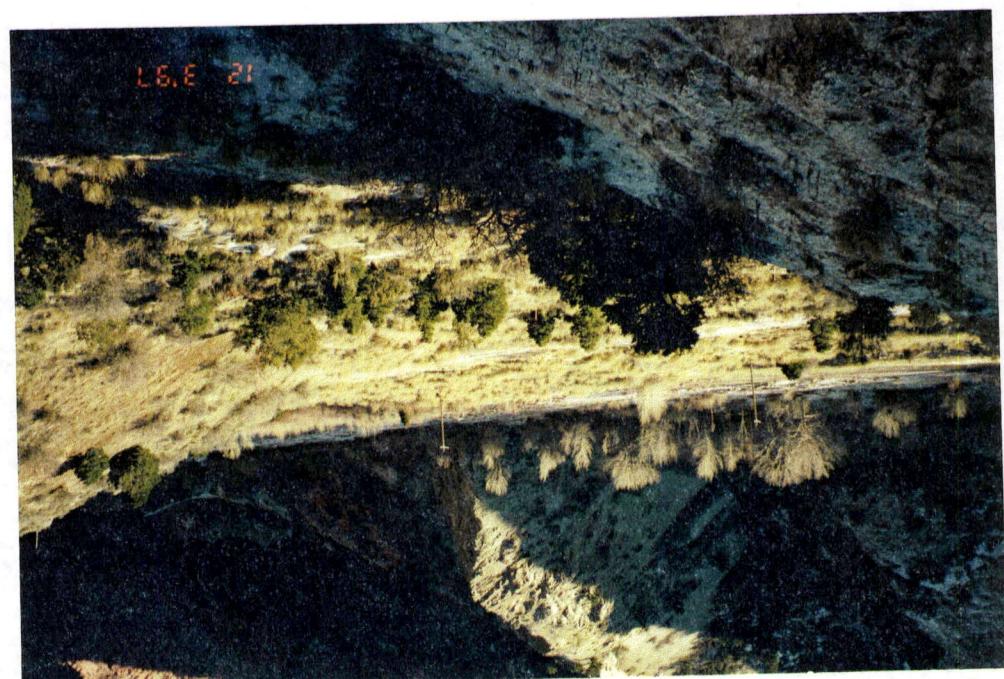
Photo of northern end of  
existing mine disturbance.  
View looking NE
